PROPERTY CONDITION REPORT

123 Maple Street
Anytown, Missouri 12345

Prepared for: Joe & Jane Smith

Prepared by: Missouri Property Inspections, LLC
PO Box 538
Troy, Mo 63379
ASHI Certified #245478
Paul Reichle, Inspector

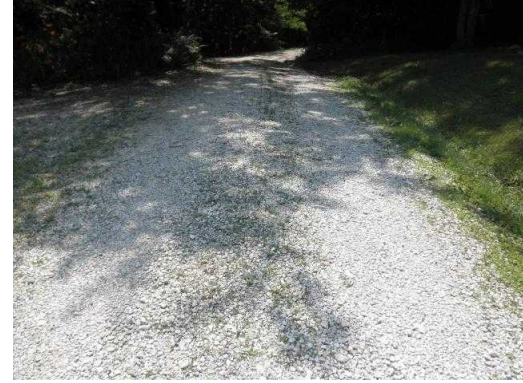
Driveway: *Gravel, - Driveway is in good condition for the age of the home*

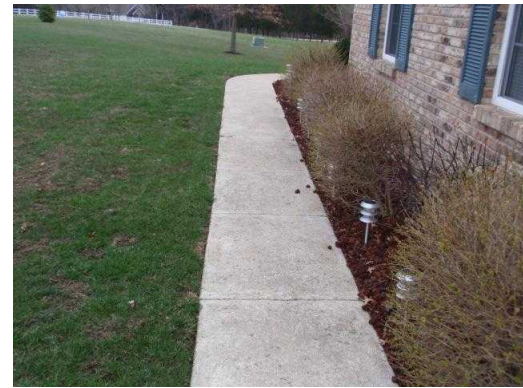
Walks/Steps: *Concrete, - Sidewalk is in good condition for the age of the home*

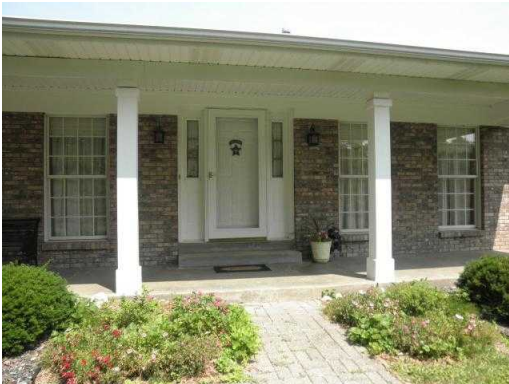
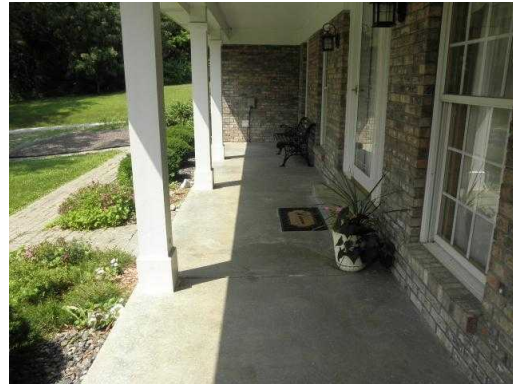
Porch: *Concrete, - Concrete porch is in good condition for the age of the home*

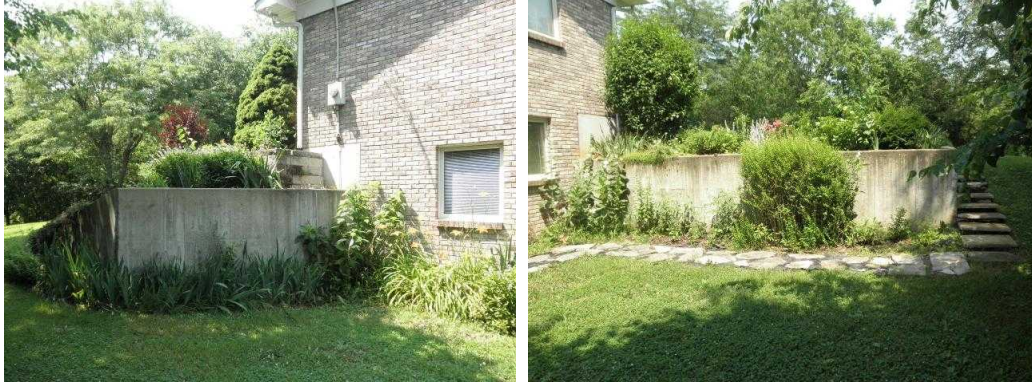
Retaining Walls: *Concrete, - Both retaining walls are in acceptable condition.*

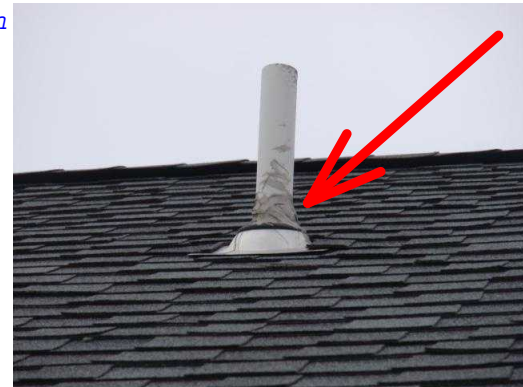
1. Plumbing Vents: *PVC, - Caulking was observed on several plumbing vent stack boots. This is an indication of possible leaking. I recommend further evaluation and/or replacement by a qualified roofing contractor.*

9. *Marginal* Plumbing Vents: *PVC*, - *Caulking was observed on several plumbing vent stack boots. This is an indication of possible leaking. I recommend further evaluation and/or replacement by a qualified roofing contractor.*

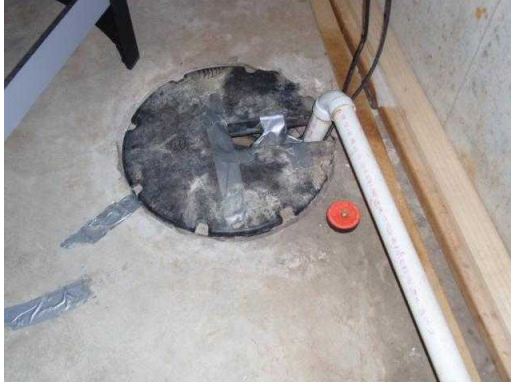
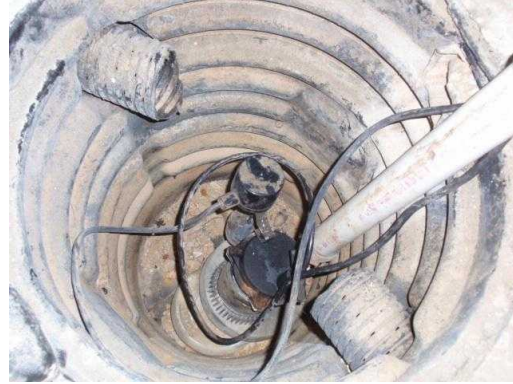
Sump Pump: *Sump is covered and dry. Pump motor worked when tested.*

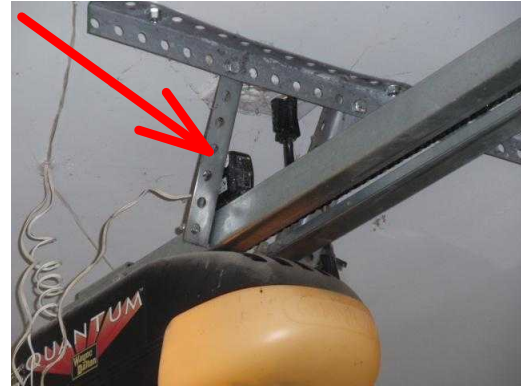
2. Attached Garage Door Opener: *Lift Master, - Electric eye for reverse function is not installed in proper position on the sides of the doors. Currently they are mounted on top of the opener which does not provide the protection as designed. Recommend further evaluation and repair by a qualified garage door technician.*

4. *Marginal* Door Opener: *Lift Master, - Electric eye for reverse function is not installed in proper position on the sides of the doors. Currently they are mounted on top of the opener which does not provide the protection as designed. Recommend further evaluation and repair by a qualified garage door technician.*

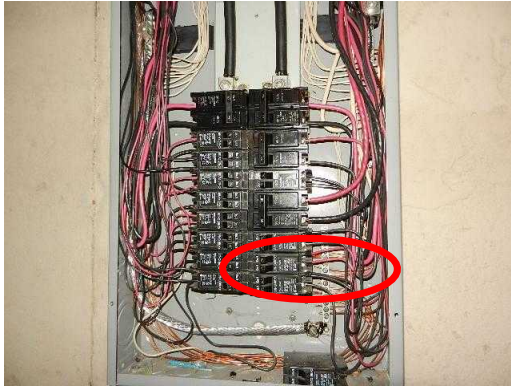
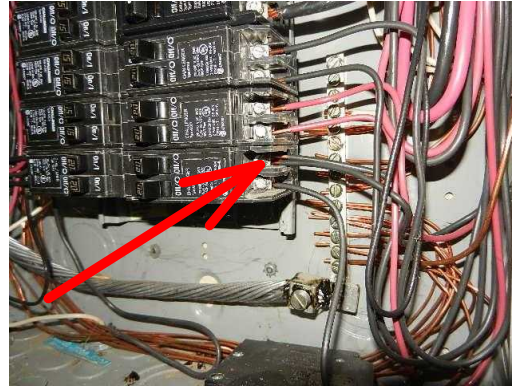
3. Basement Electric Panel Manufacturer: *Cutler-Hammer, - Double taps present. I recommend repairs by a qualified electrician.*

8. *Marginal* Manufacturer: *Cutler-Hammer*, - *Double taps present. I recommend repairs by a qualified electrician.*

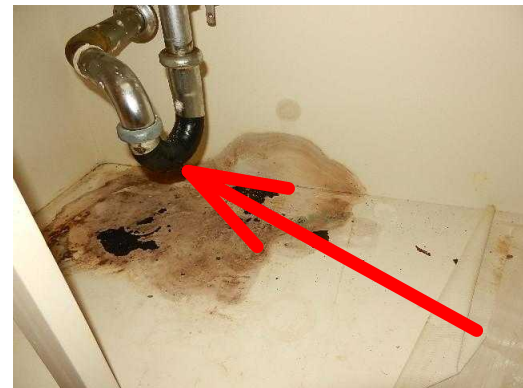
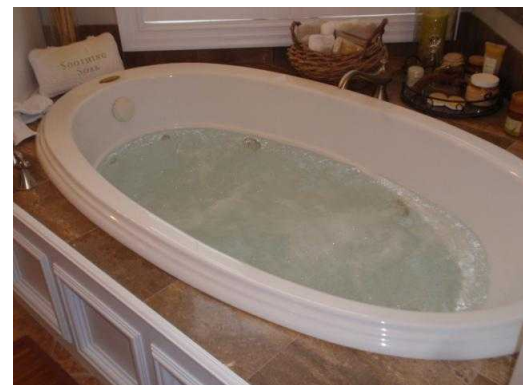
8. *Marginal* Faucets/Traps: *Chrome fixtures with a metal trap, - Unconventional repair observed on the trap. What appears to be mold/mildew was observed on the cabinet floor and wall. The extent and/or type of mold/mildew is beyond the scope of this inspection. I recommend further evaluation and testing by a qualified contractor.*

9. *Acceptable* Shower/Surround: *Fiberglass pan with cultured marble surround*
10. *Marginal* Spa Tub/Surround: *Fiberglass tub and ceramic tile surround, - The jetted tub is not GFCI protected. Recommend further evaluation and repair by a licensed electrician. Service access on side of tub*
